DESIGN AND CONSTRUCTION OF FABRIC REINFORCED  
RETAINING WALLS BY NEW YORK STATE

Gary E. Douglas, Senior Soils Engineer  
Soil Mechanics Bureau  
New York State Department of Transportation  
1220 Washington Avenue  
Albany, New York 12232

This paper relates the experience of New York State in the design and construction of two fabric-reinforced retaining walls. Crushed stone fill is reinforced by horizontal layers of fabric placed at intervals dependent upon the height of the wall, the strength of the fabric, and the internal friction angle of the fill. Design and construction procedures are detailed, with emphasis on practical construction techniques.

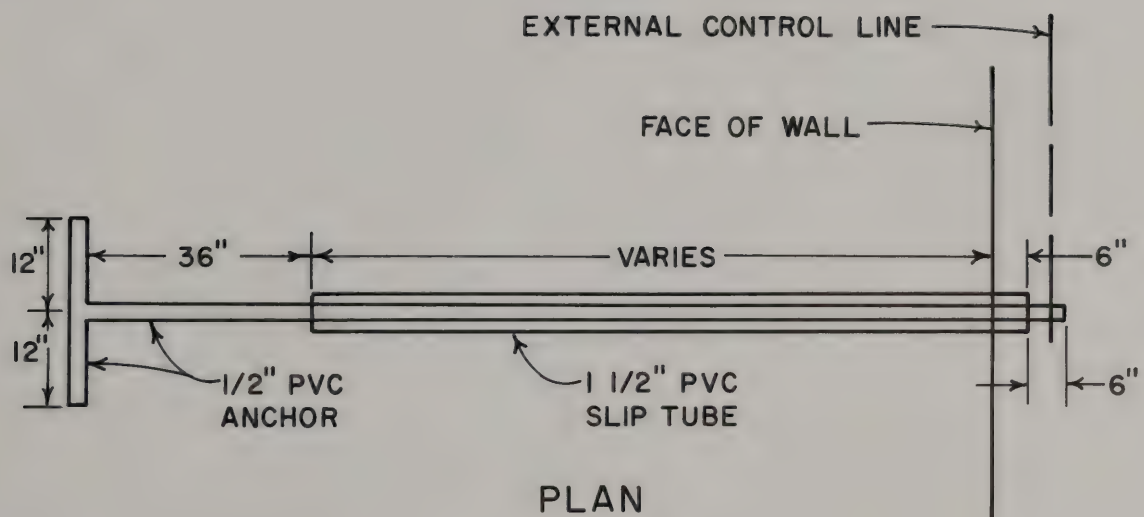
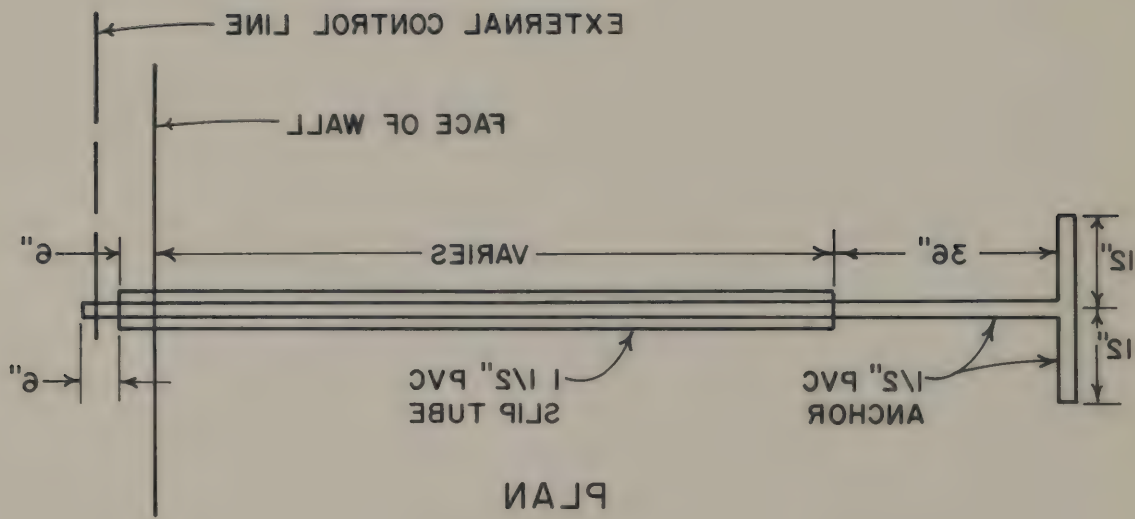
FIGURE 10

A slip tube (Figure 10) is free to slide on an anchor rod which extends 3 feet beyond the tube. Internal horizontal movements of the fill, are indicated by the change in distance between the end of the slip tube and a scribe mark on the inner rod. The scribe mark is referenced to an external control line. Thus, the relative movement and the absolute movement of the tube can be determined.

The tubes were installed in sets of four at various elevations to investigate the pattern of lateral movement. The tubes were buried 3, 6, 9, and 12 feet into the wall, with each anchor rod extended 3 additional feet beyond its respective tube. With anchors equal in length to the longer of the adjacent tubes, the wall is divided into several observation zones. Movements were compared within sets of tubes, and with corresponding length tubes at different elevations. Many tubes showed no movement while others have not exceeded 0.25 inches, as late as one year after construction. Possibly, any short-term movements occurred during construction, before the control points were set, or only small movements have occurred. Generally, the shorter tubes have shown the most movement, although continued monitoring may reveal a more definite pattern.

TYPICAL SLIP TUBE

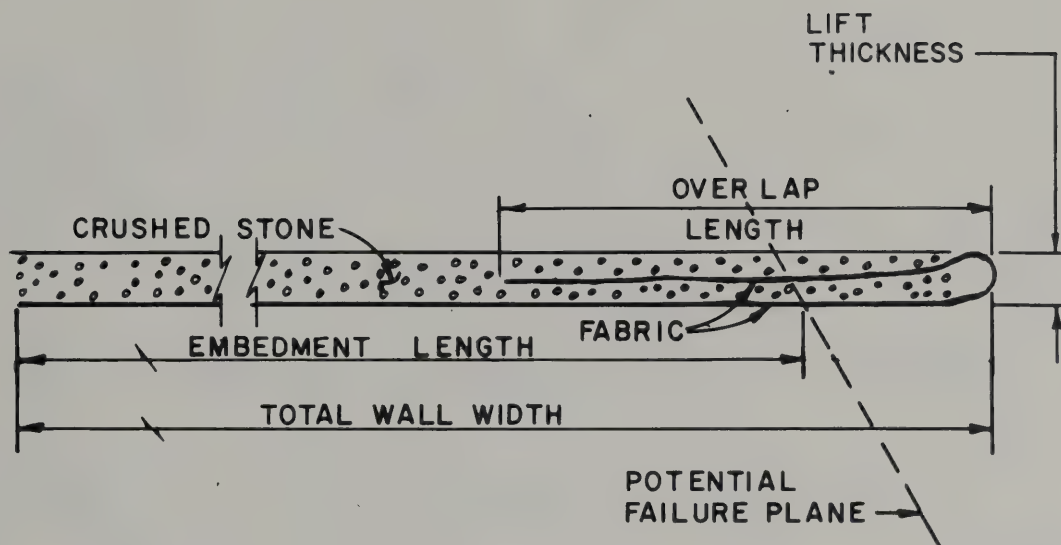
FIGURE 2

The design is based on methods described in a U. S. Forest Service publication (1). The wall is designed as lifts of alternating fabric reinforcement and stone fill, as shown in Figures 2 and 3. The fabric within the theoretical failure zone cannot mobilize tensile strength to resist internal failure, and is therefore discounted when calculating the reinforcing length required. The fabric length embedded behind the theoretical failure plane is the fabric which reinforces the fill. The lift thickness is formed by the fabric which overlaps the face of the wall and retains the fill material.

## TYPICAL LIFT DETAIL

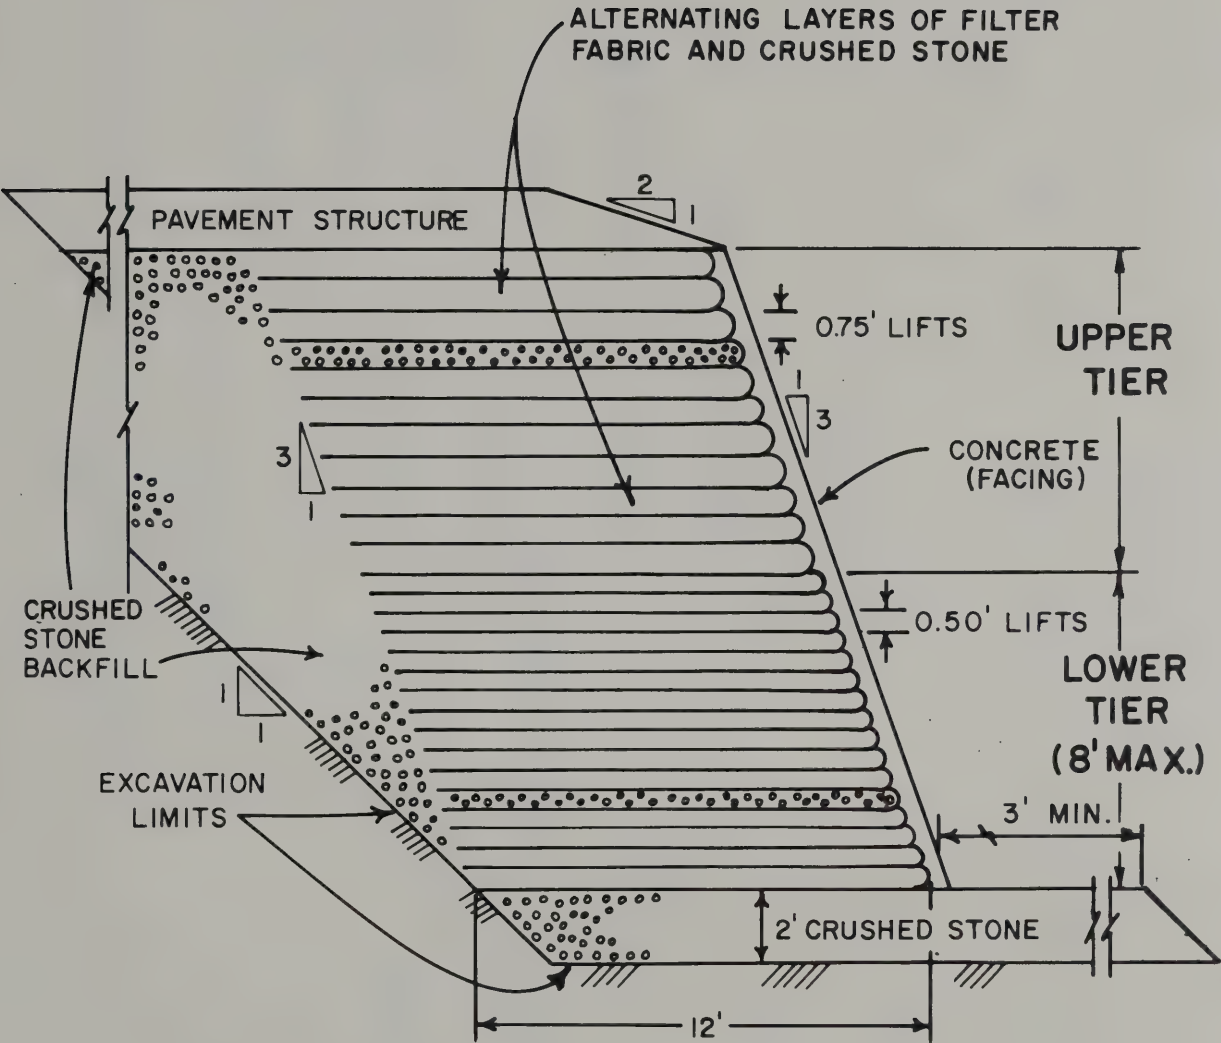
FIGURE 3

The final cross-section dimensions, shown in Figure 3, were obtained by adjusting the calculated values to use the full manufactured width of fabric rolls, 17.4 feet. The wall was designed in two tiers, each with a different maximum lift thickness. The two tier design was selected for practicality in construction, since the theoretical lift thickness may vary continuously with depth and pressure below the top of the wall. The overlap dimension was allowed to vary with the lift thickness to keep the wall width constant.

TYPICAL WALL SECTION

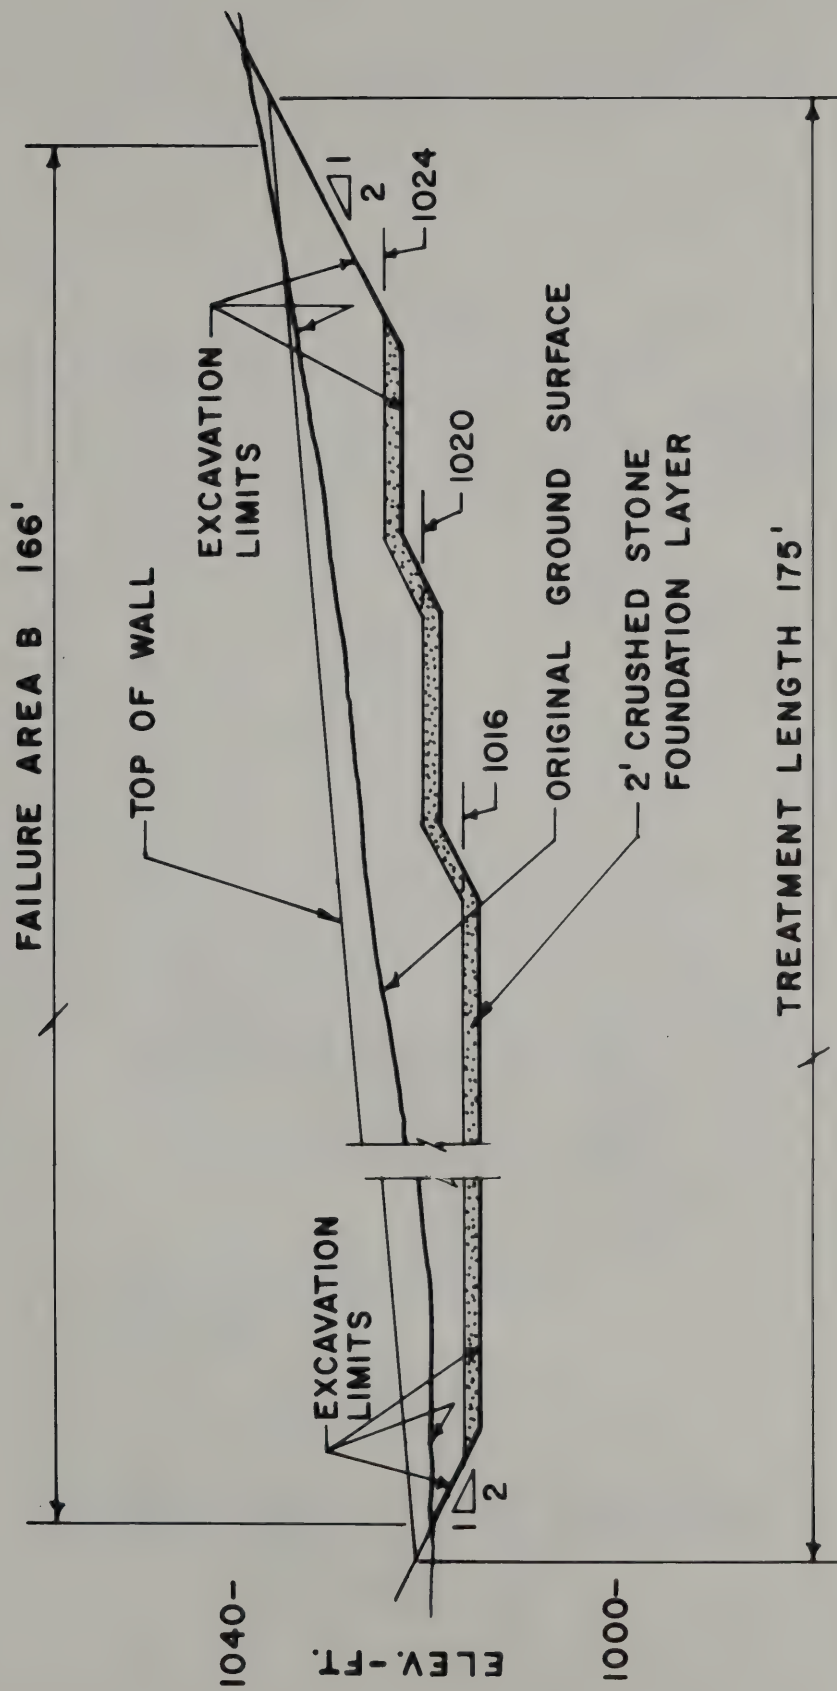
FIGURE 4

The excavation was progressed to the limits shown in Figure 3 while maintaining one-way traffic on the adjacent lane. The excavation was confined to one lane by using a 1 vertical on 1 horizontal backslope as the steepest allowable unbraced slope. The excavation was benched at elevations determined from analysis of boring logs and confirmed by field inspection, to remove weakened material and establish the wall foundation on undisturbed compact soil. The transition between benches and the end slopes were 1 vertical on 2 horizontal.

EXCAVATION LIMITS FOR AREA B

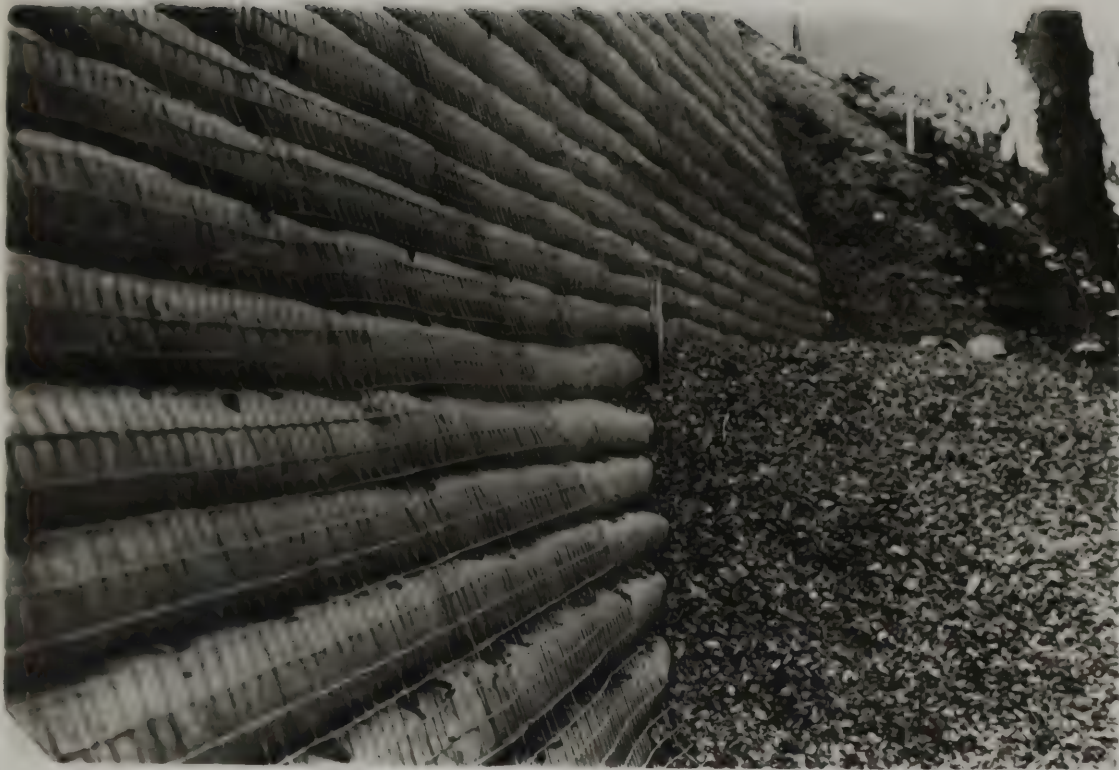
FIGURE 13

The rebar grid set for the reinforcing mesh required the addition of a top and bottom row. These bars were installed after construction with minimal effect on the fabric. Future installations should specify a top and bottom row of rebars. The 3 foot square grid should be modified, perhaps by staggering alternate rows of rebars. Construction joints in the concrete face seem desirable to reduce cracking. Vertical construction joints, 50 feet on center, were included in the second wall.

WALL FACE WITH REINFORCING MESH IN PLACE

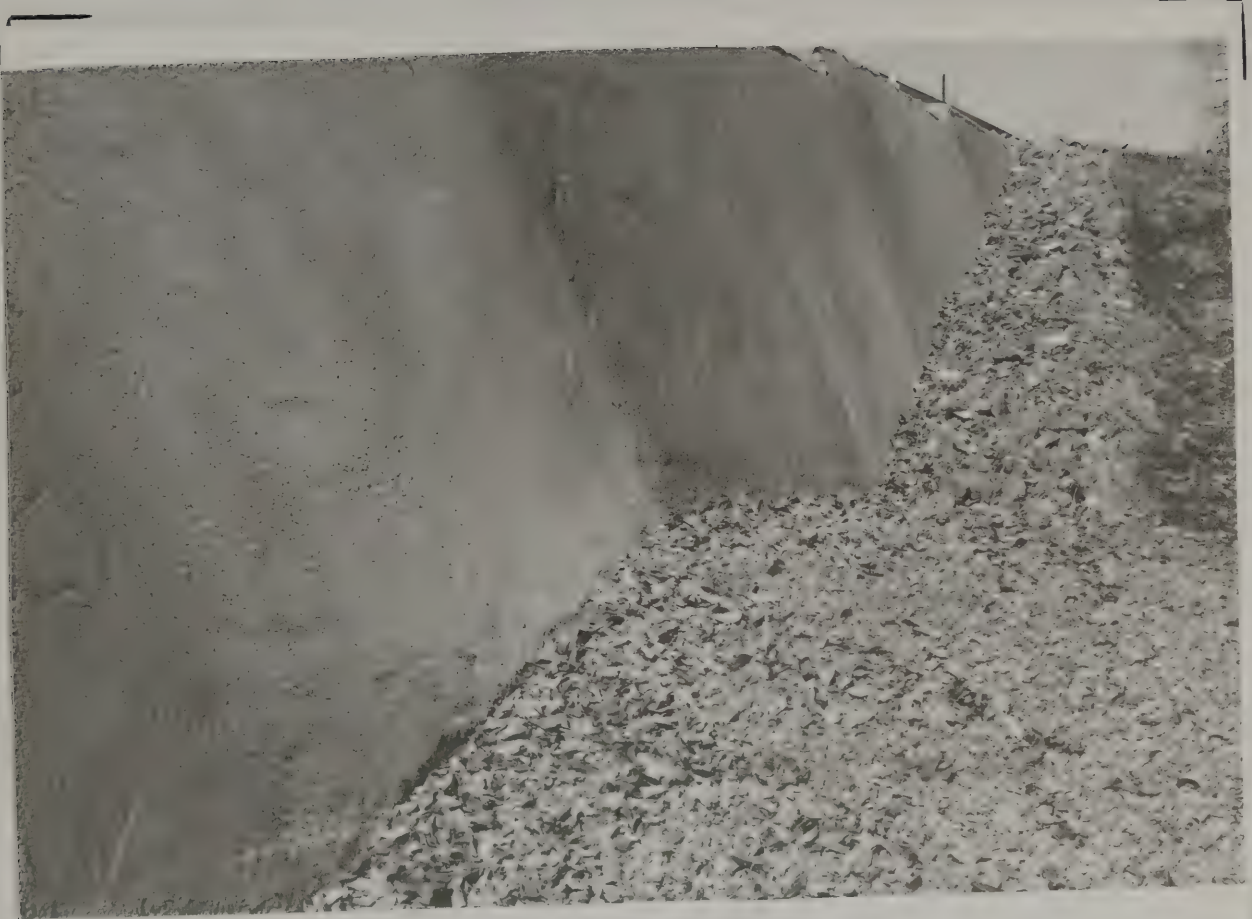
The fabric was chosen mainly for its strength and permeability, although some resistance to ultra-violet deterioration was also desired. The maximum allowable exposure time for the fabric was specified as two weeks. However, for permanent protection, low-maintenance, and vandal protection, the wall face was covered with a mesh-reinforced pneumatically projected concrete. The reinforcing mesh, specified to be manufactured from No. 12 wires spaced 2 inches in each direction, was supported using No. 3 rebars inserted between layers to a depth of 3 feet. The bars were placed between layers during construction to form a grid measuring 3 feet by 3 feet. The mesh was included to minimize possible settlement cracks in the rigid concrete surface of the flexible wall. (Figure 9)

CONCRETE FINISH ON FACE OF WALL  
FIGURE 14

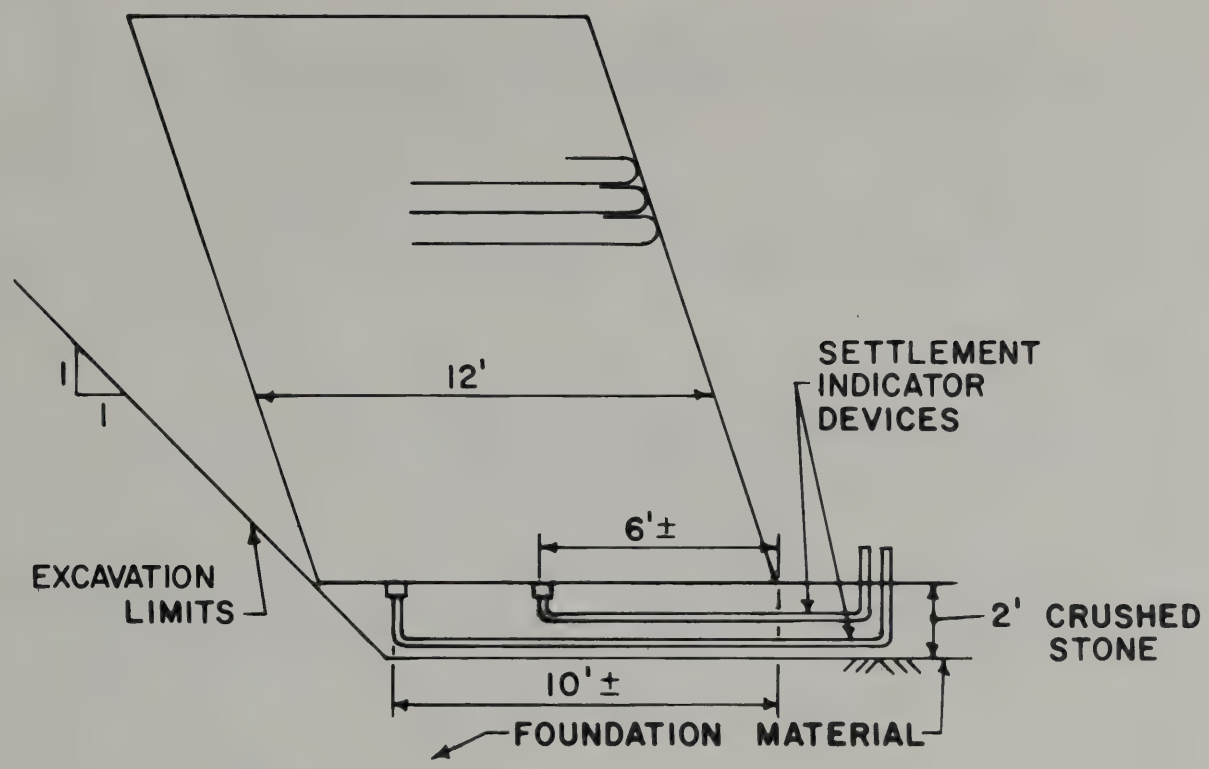
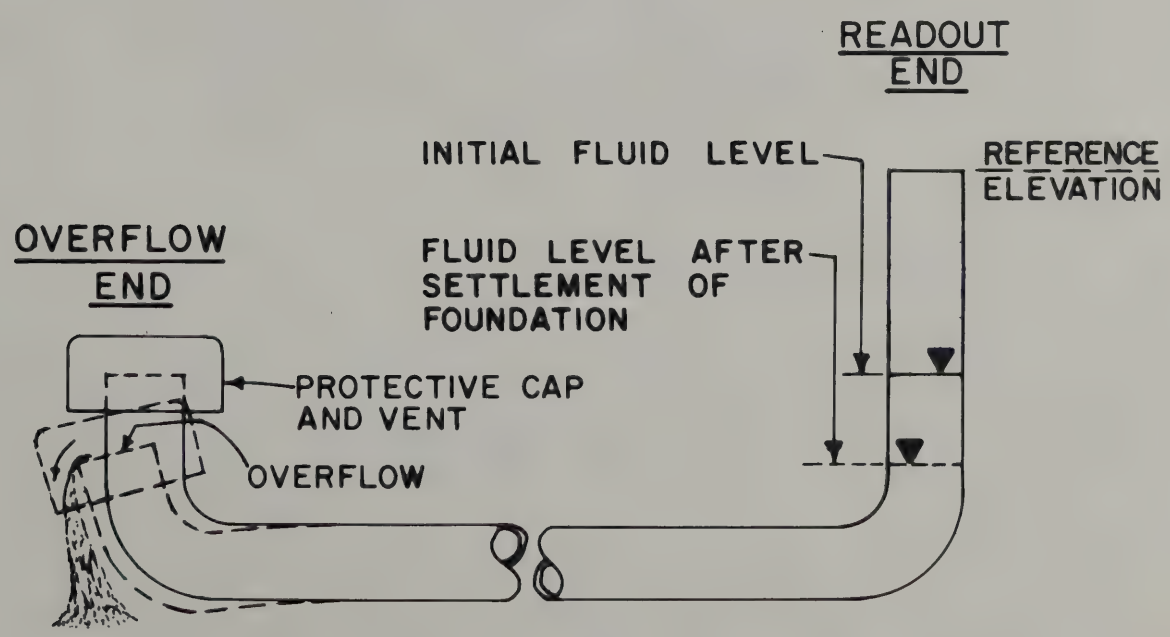
The settlements measured during construction were less than one-quarter inch. At Wall B, the settlement measured one year after construction was 1.32 inches at both devices. At Wall A, settlements measured eight months after construction were 0.5 inches and 0.25 inches at the devices 6 feet and 10 feet from the toe of the wall, respectively. (These were the last measurements before the Wall A devices were vandalized.) These settlements have caused no noticeable effect on the roadway structure or the rigid concrete face.

SETTLEMENT INDICATOR INSTALLATION  
FIGURE 15

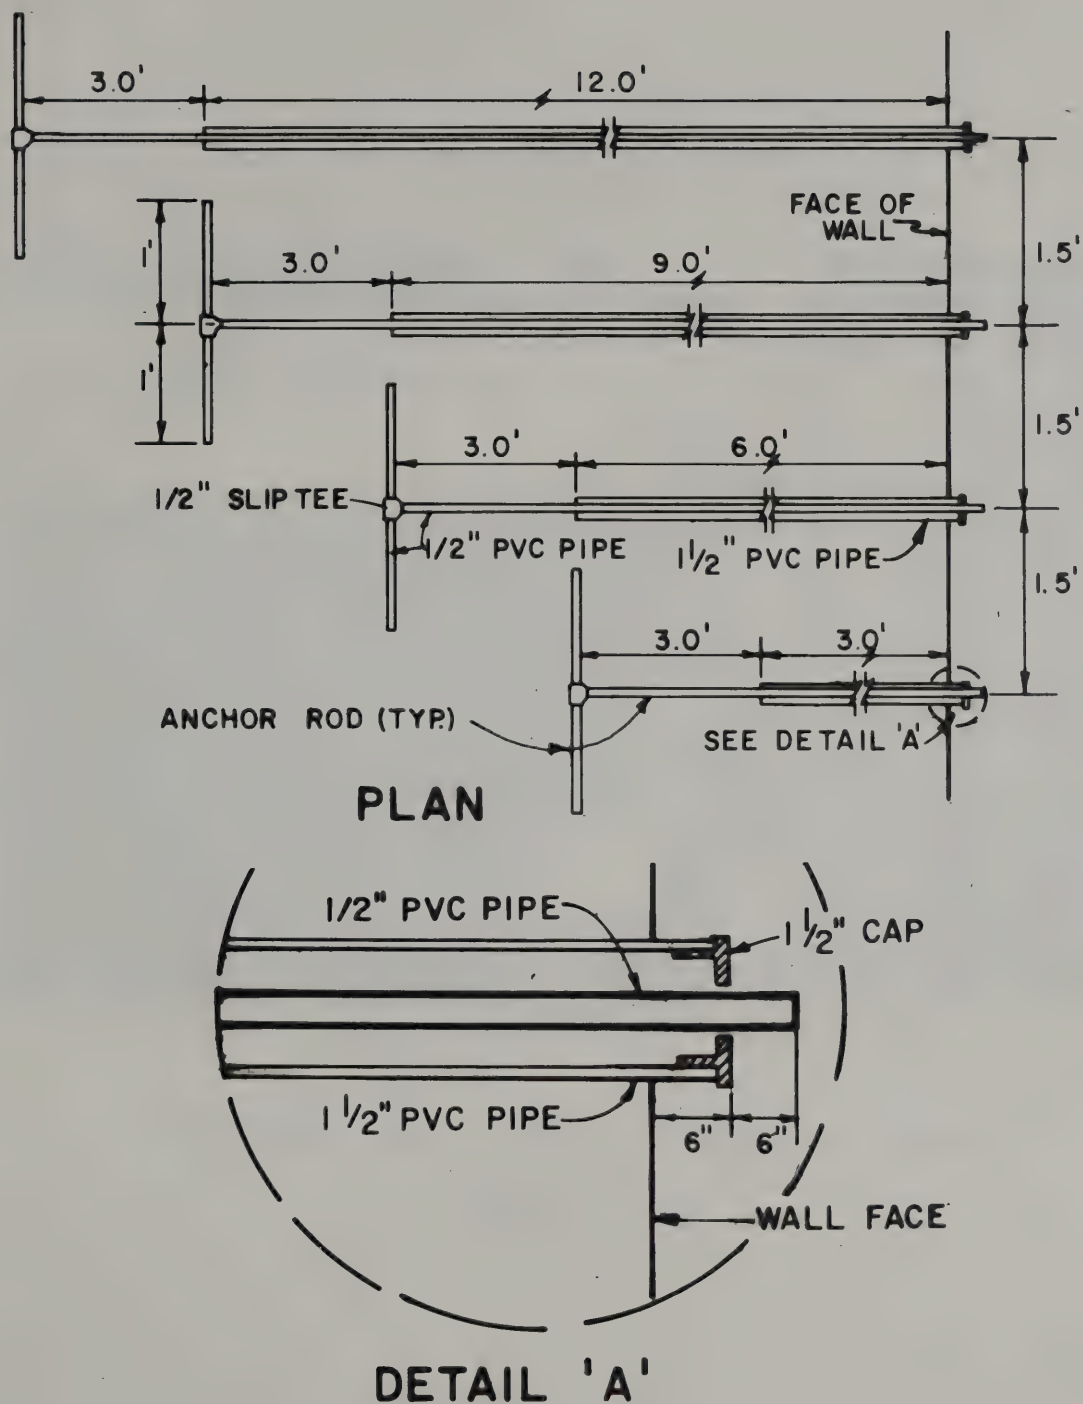
FIGURE 16

TYPICAL SLIP TUBE INSTALLATION
